## Window regulator rebuild - February 2004

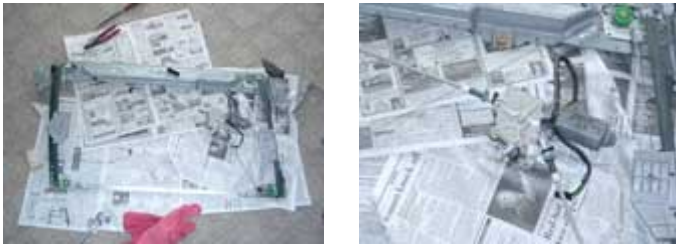
up. Further, verify the rubber 'seal' is located on the remaining plastic gear set in the motor housing, and install the spool housing to the motor housing. Line up the bolt holes and rock the spool and motor together; if everything is lined up it should go together easily. Install the 5 bolts and tighten them in a crossing manner (again, according to Sir Bentley). When all is said and done, you should have a shiny, rebuilt regulator assembly:

3. Next I assembled the spool/cable housing to the motor. According to the Bentley, I first installed the plastic vane into the new spool; the three vanes insert between two rubber pieces each, double-check you have all six and they're lined
